TOWN OF CANTON

WEST MOUNTAIN ROAD REPORT

March 21, 2023

Town of Canton Tree Evaluation

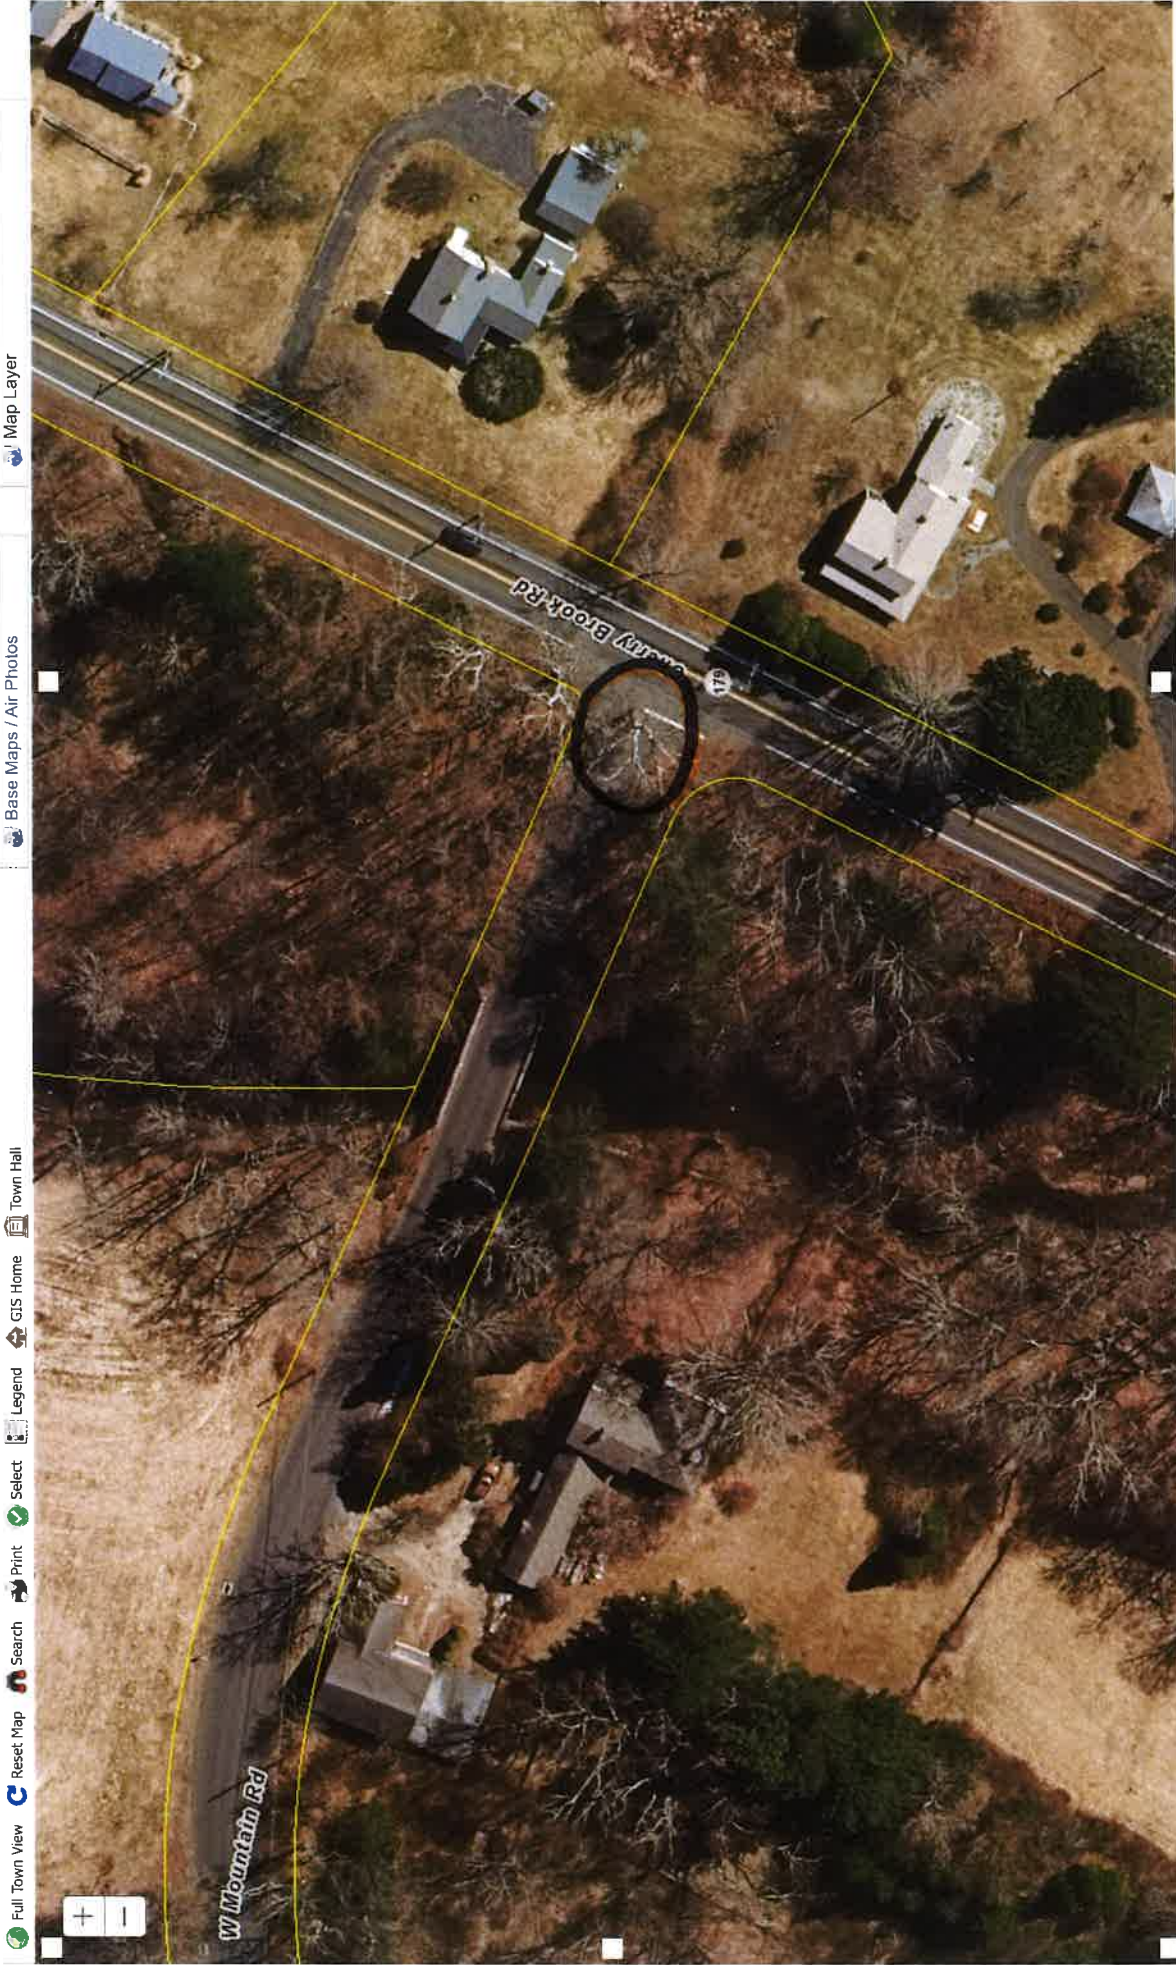
I inspected the tree with Arborist Steve Bristol. When inspecting the tree, we found it to be in good health. The tree has asphalt surrounding it on all sides but that does not appear to be affecting the health of the tree. We did notice debris pushed up against the trunk of the tree which should be removed to prevent the trunk from developing decay. We can perform tests to see if the tree has any decay in the trunk but I would not advise that test at this time.

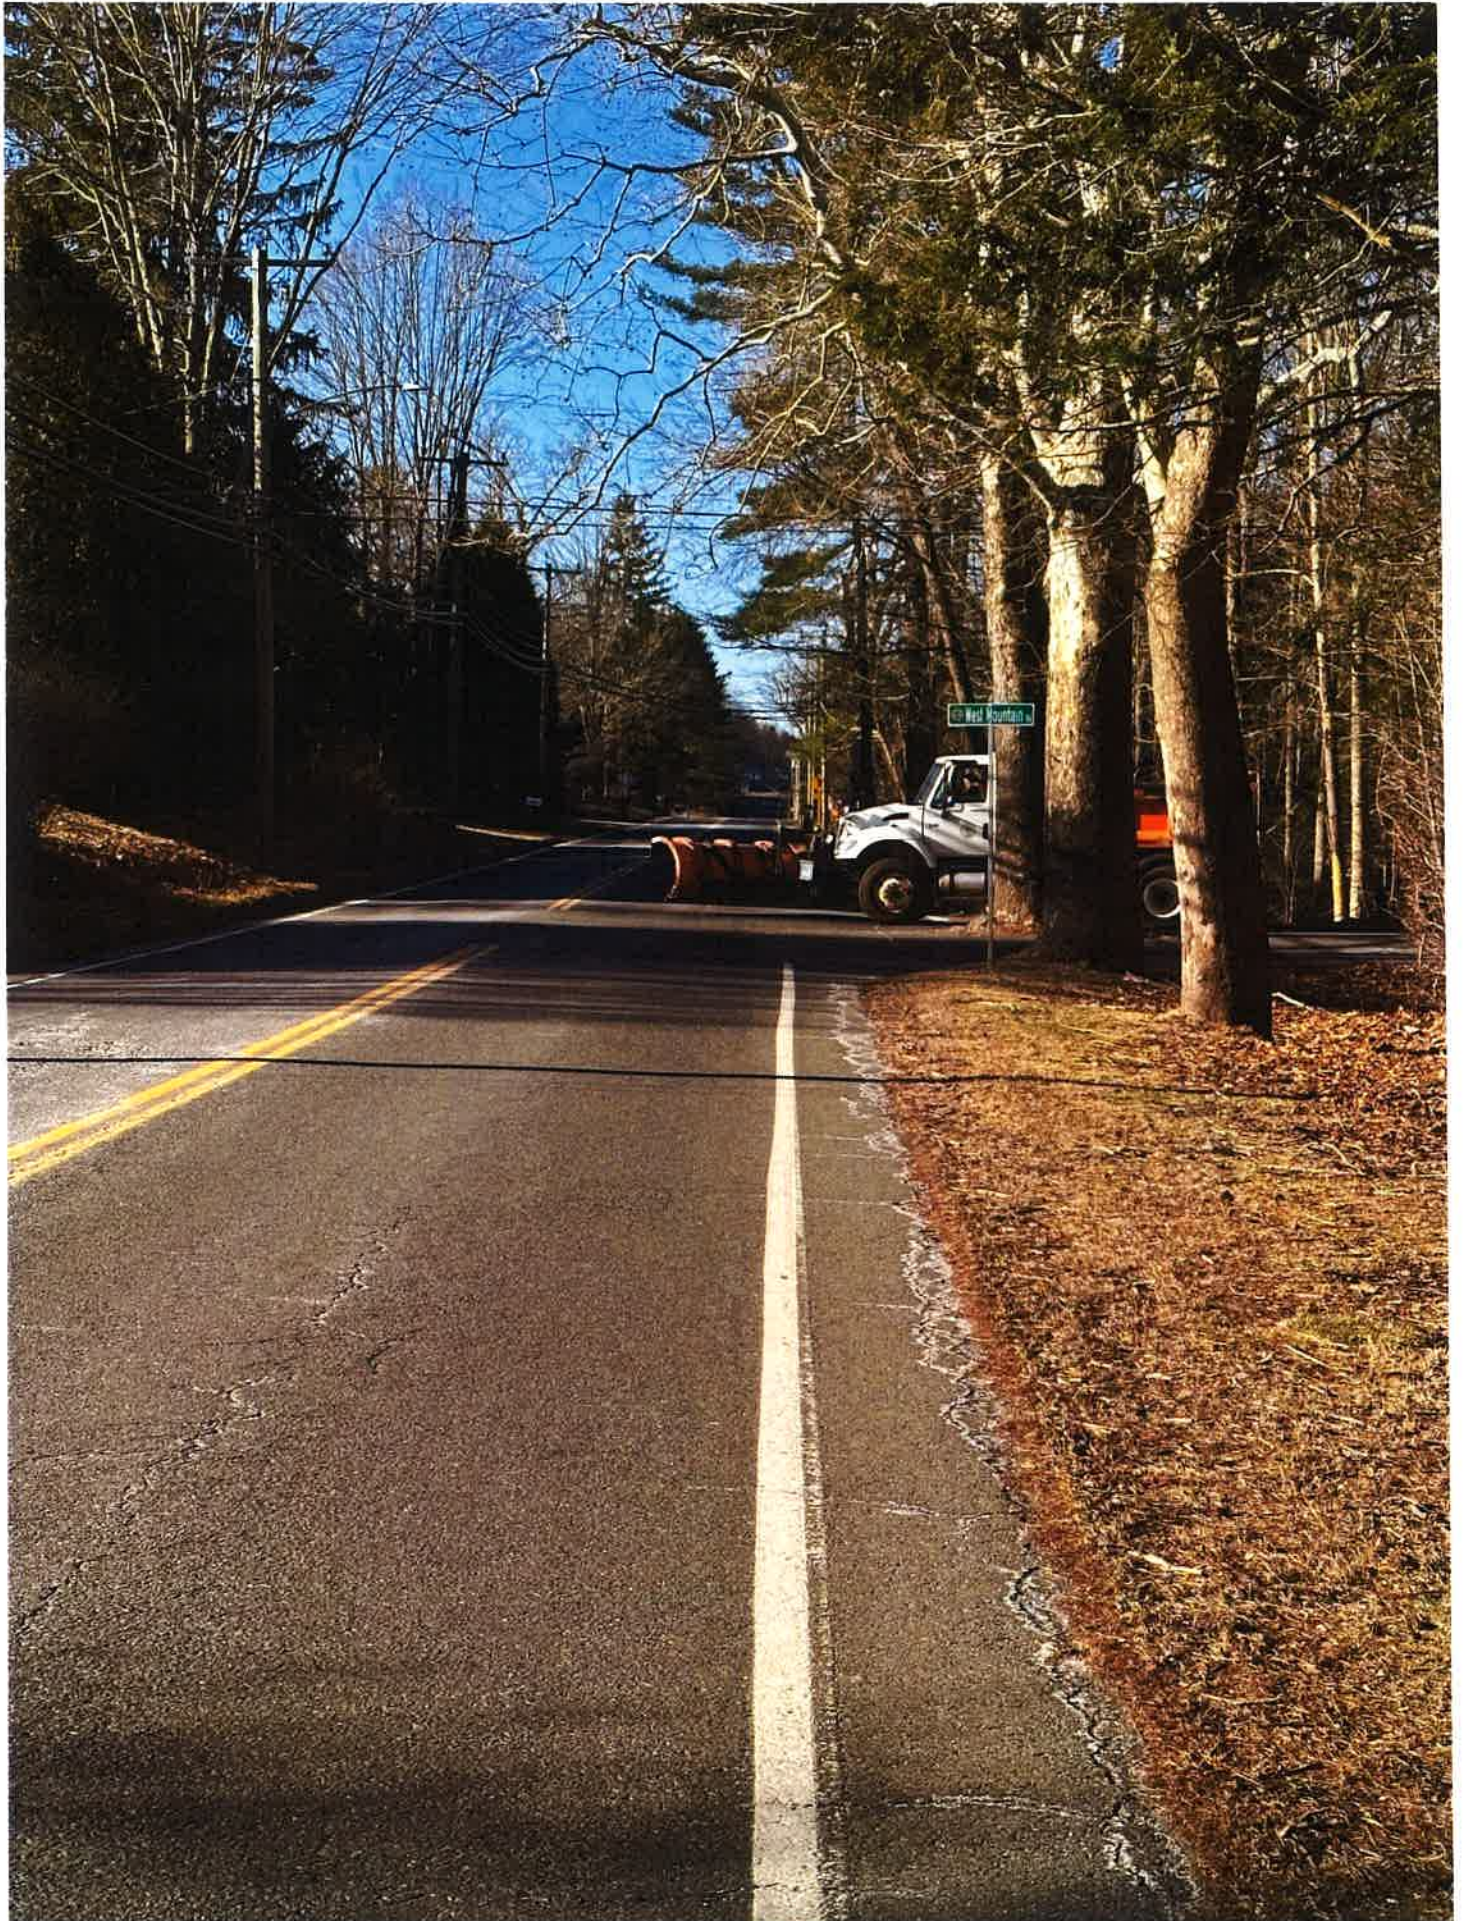
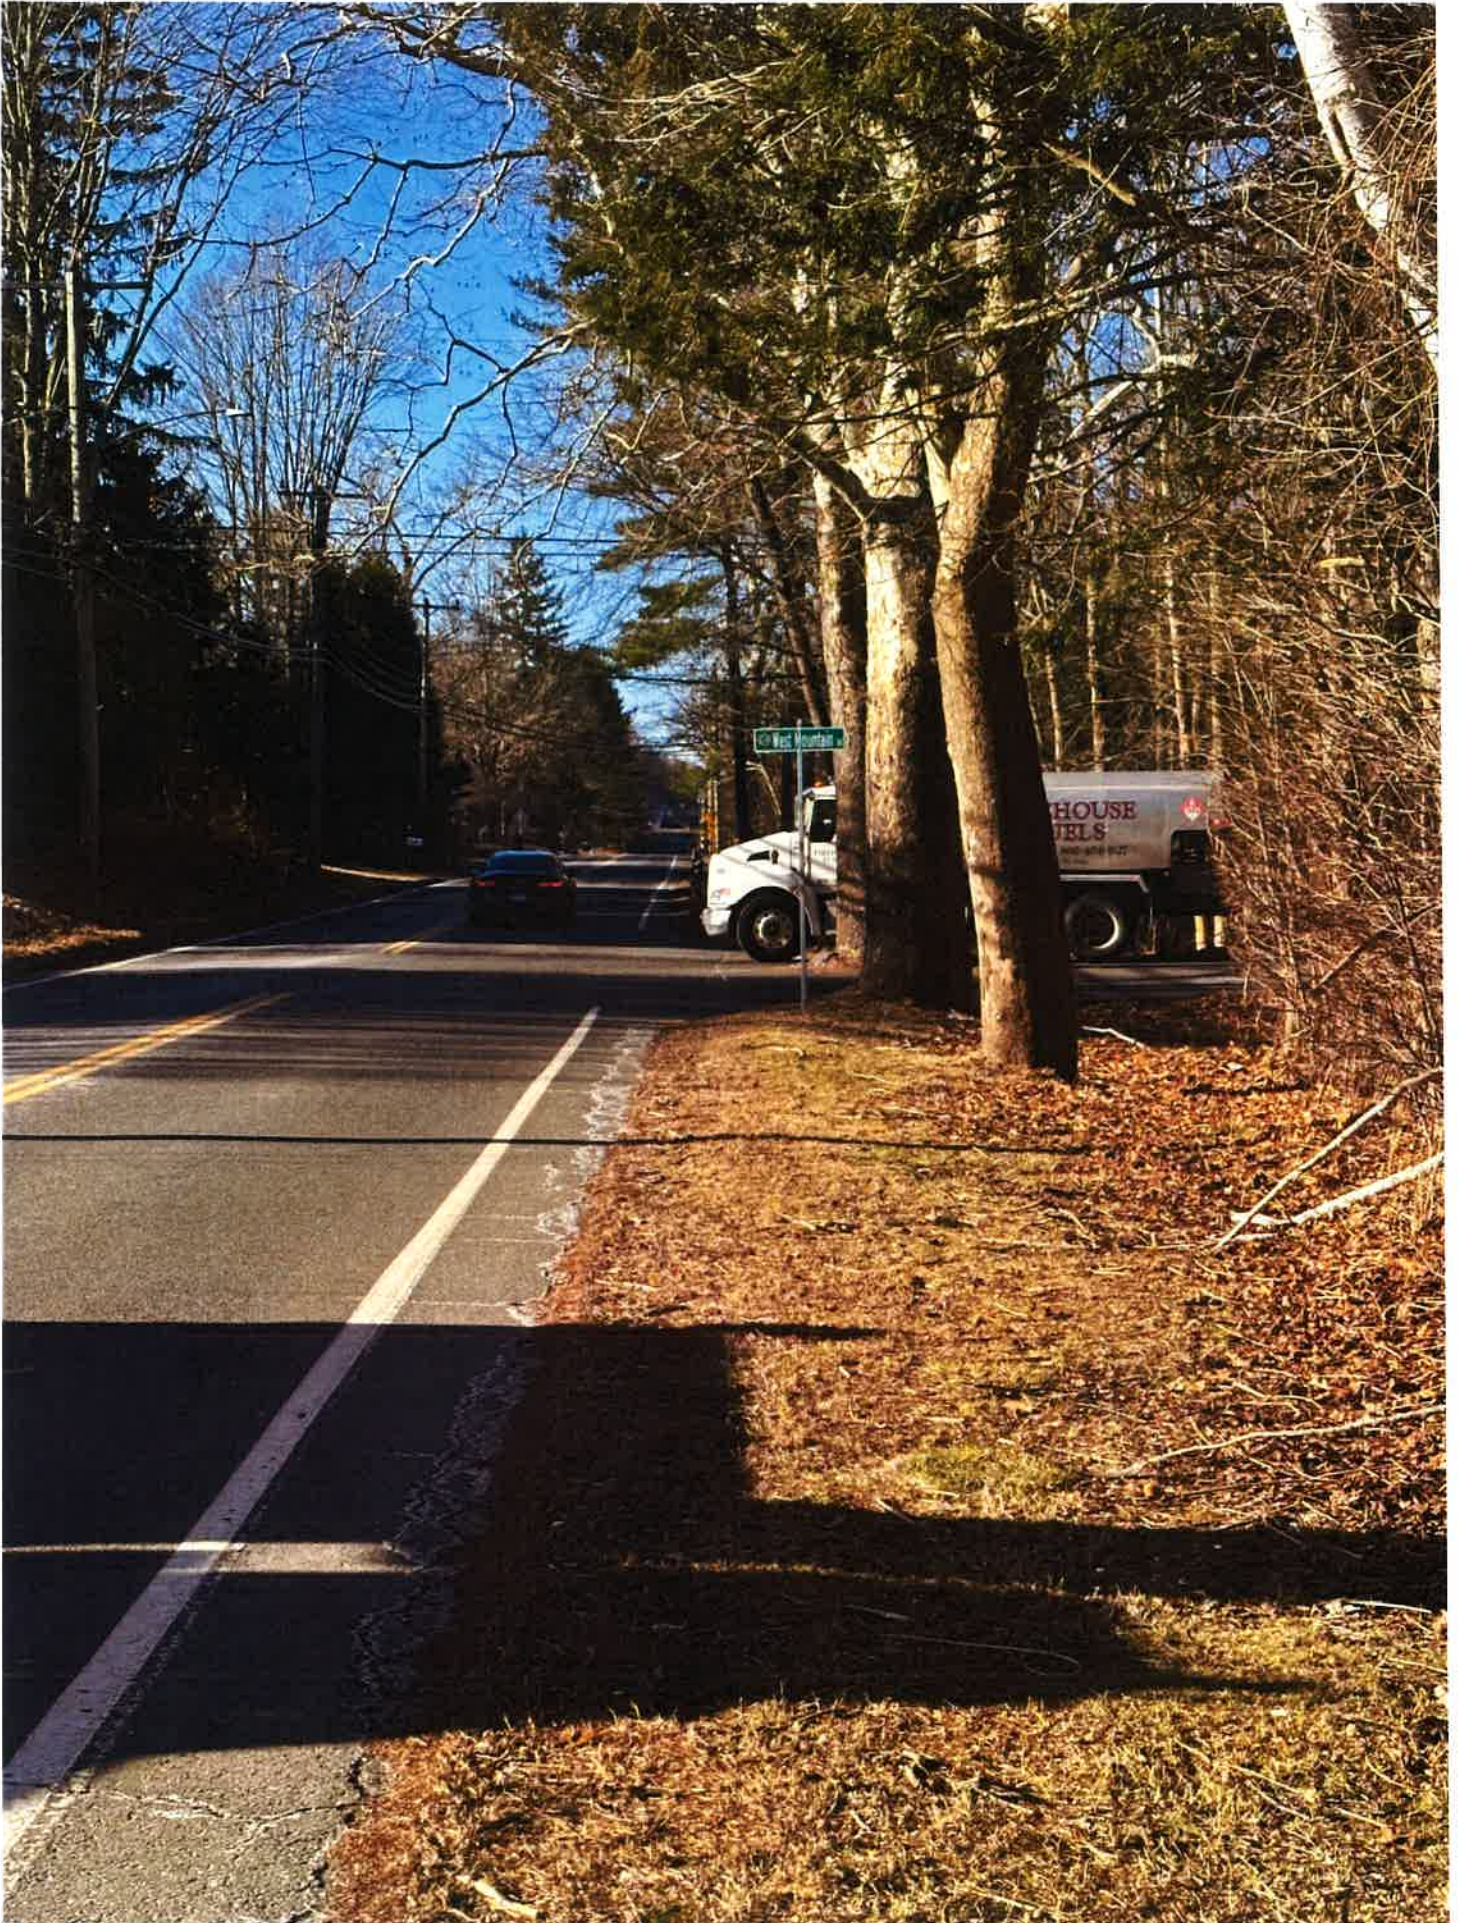
- There are additional concerns that large vehicles, particularly with snowplow blades, exiting from West Mountain Road are extended further onto Cherry Brook Road to improve sightlines. Moreover, some large trucks turning left onto West Mountain Road do so to the left of the TREE which adds another safety concern due to the location of the TREE and traffic on West Mountain Road. (See attached photos).

1. Cut down the TREE and the two Sycamores north of the West Mountain/Cherry Brook intersection to improve the sight distance.
2. Cut down the TREE, only and reassess the sight distance with the two remaining Sycamore trees.
3. Cut down the two Sycamores north of the West Mountain/Cherry Brook intersection to improve the sight distance. Re-assess the sight distance and monitor the future growth of the TREE.
4. Retain a licensed traffic engineer to conduct a recognized sight distance analysis as to intersection sight distance and stopping sight distance.
