# ANNUAL REPORT

TOWN OF CANTON  
JANUARY – DECEMBER 2023

# 2023 MS4 ANNUAL REPORT

MS4 General Permit  
Town of Canton 2023 Annual Report  
Permit Number GSM 000091  
January 1, 2023 – December 31, 2023  
Primary MS4 Contact: Robert J. Martin, Director of Public Works  
860-693-7863, [rmartin@townofcantonct.org](mailto:rmartin@townofcantonct.org)

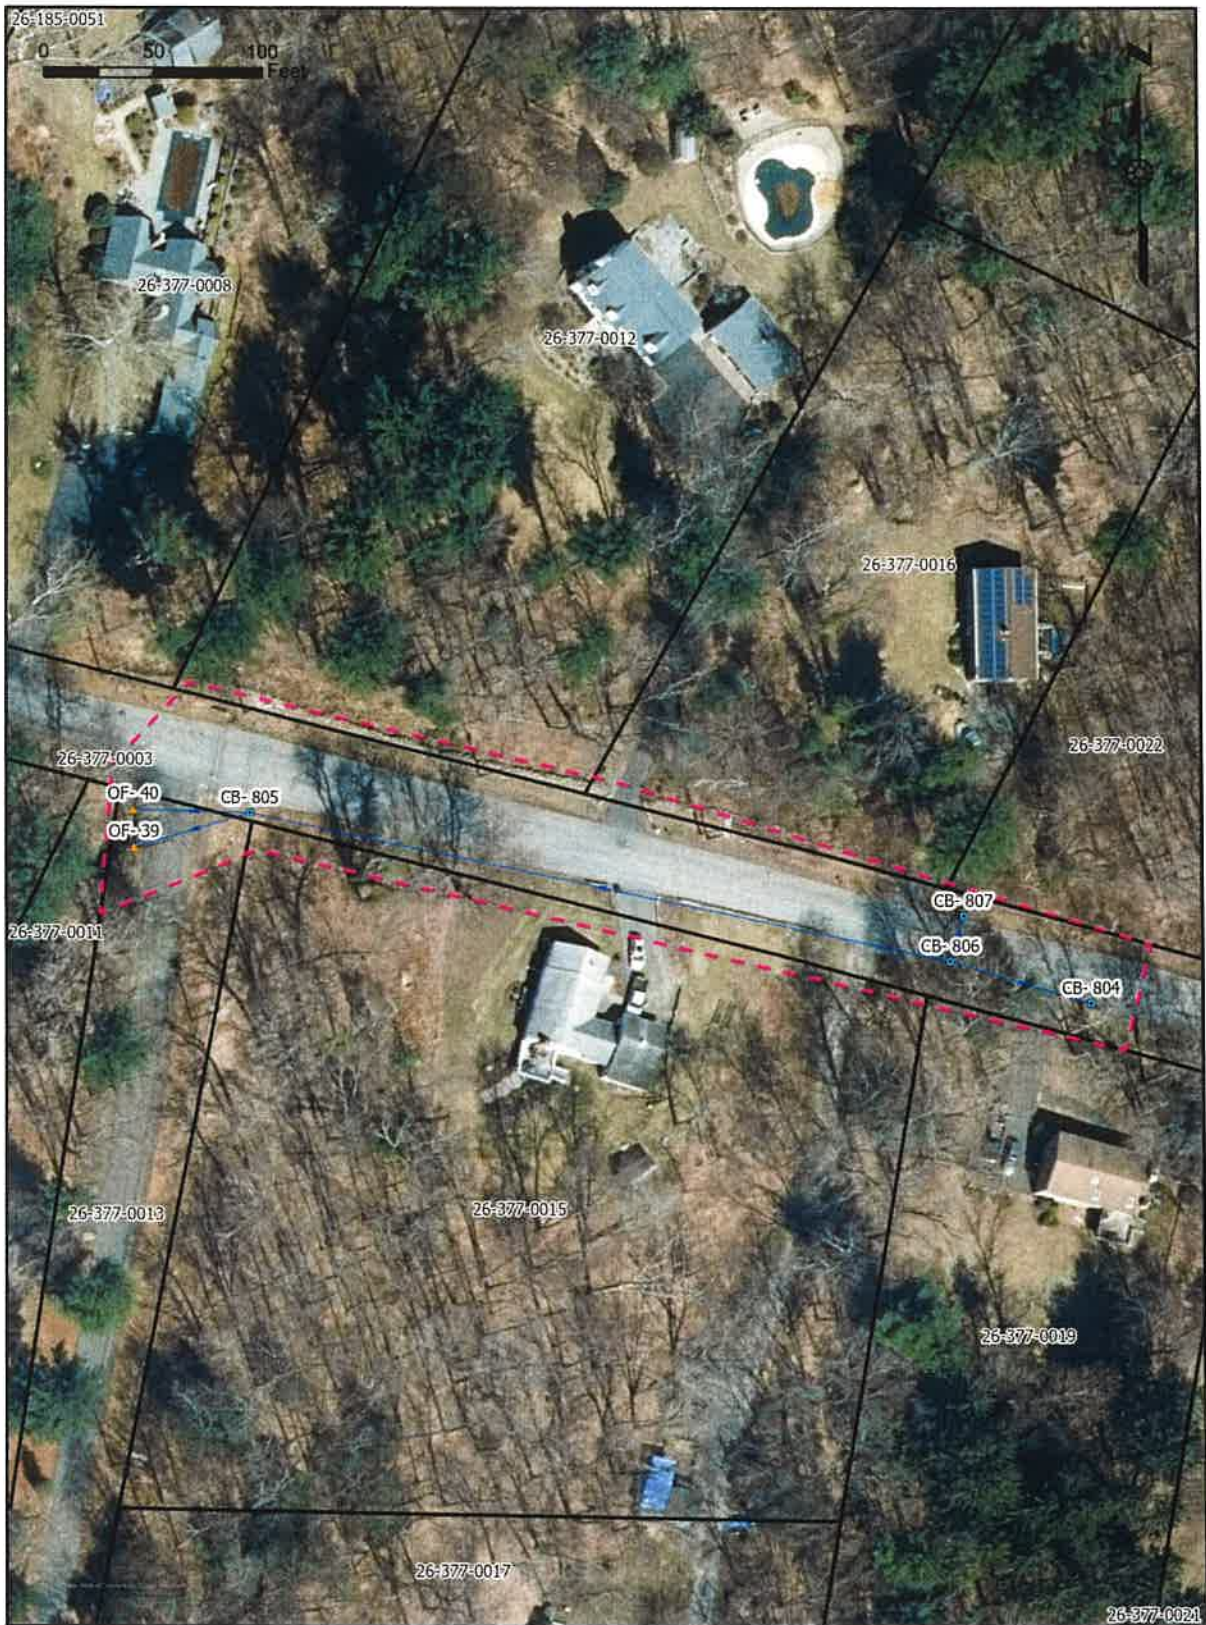
2023 Annual Report  
OF-39/40 Catchment  
Investigation

Any additional observations?	X		Foam was observed in CB-804 where an unidentified pipe from 19 Morgan Road property was present.

Catch Basin ID	Observations
CB-804	The catch basin was observed to be in good condition with an unidentified pipe connected to 19 Morgan Road discharging into it. Foam was observed on the surface of the discharge.
CB-806	The catch basin was observed to be in good condition and receives discharge from CB-804.
CB-807	The catch basin was observed to be in good condition and discharges stormwater to CB-806.
CB-805	The catch basin was observed to be in good condition and receives discharge from CB-806 and discharges to OF-39 across Camille Lane.
OF-39	The Outfall to the left of OF-40. This outfall collects stormwater discharge from CB-805.
OF-40	The Outfall to the right of OF-39. This outfall collects stormwater runoff coming from the left side of Morgan Road via curb inlet and drainage pipe.

**Rationale:** Atlas staff noted there were additional pipes discharging into CB-804. Samples collected from OF-40 indicated high levels of Total Coliforms and E. Coli over the past three years. Based on these observations, it is possible there is illicit discharges coming from the pipes. These pipes seem to be connected to the residential houses on Camille Lane, potentially from the house at 11 Camille Lane. In addition, septic failure data was obtained. In 2021, a failing septic tank was replaced 0.1 miles from OF-39 and OF-40. In 2023, a sewage overflow occurred 0.2 miles from the outfalls, with the leaching field needing to be replaced afterwards. These and other potentially aging septic systems may be contributing to the elevated bacteria levels in these outfalls.

Atlas recommends sampling all four catch basins and assessing if there is runoff coming from the additional pipes during a heavy rain event to determine if OF-40 is impacted by illicit discharges.

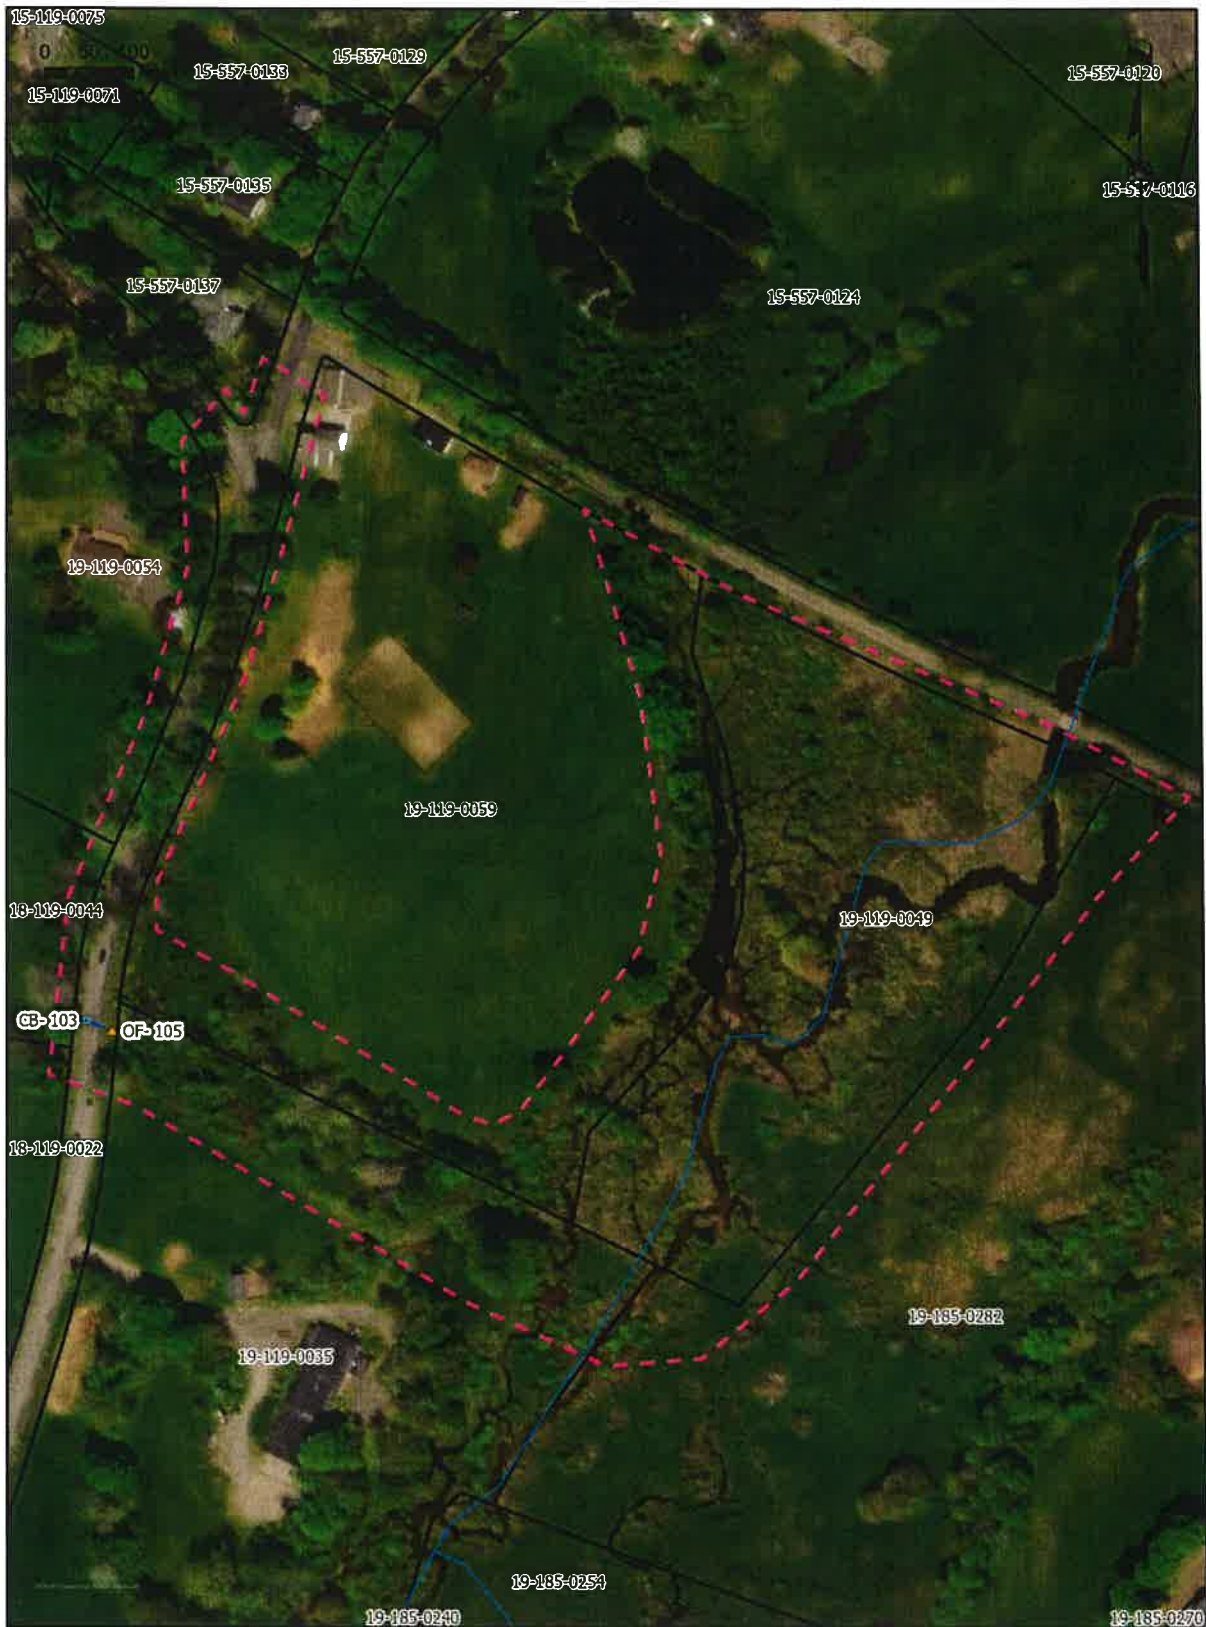
### OF-104 Catchment Investigation

Item/Condition to be checked	Observations
Outfall description	A subsurface pipe connected to CB-103 discharges to an inlet on the side of the road. The Outfall is in poor condition. Sediment has accumulated in the inlet swale as well as upgradient along the side of Barbourtown Road.
Where is the outfall located?	On Barbourtown Road, northeast of Cow's Coop (24 Barbourtown Road).
Where does the outfall discharge to?	The outfall discharges directly to an ephemeral stream (unnamed) and eventually to the Cherry Brook to the east.
How many catch basins are connected to the outfall? Where are they located?	CB-103 is located immediately west of the outfall across Barbourtown Road.
What is the direction of flow within the catchment.	Water flows south along Barbourtown Road via sheet flow towards CB-103 and the outfall.
What is the primary land use within the catchment?	The surrounding land consists of residences and agricultural land. The property directly east of the outfall houses cattle and horses.

Any additional observations?	X		Cattle hoofprints were observed in the mud where the inlet discharges the stormwater.

**Rationale:** Atlas staff noted there was a pasture with cattle and horses on land adjacent to the outfall (Parcel No. 19/119/0059). Samples collected from OF-104 indicated high levels of Total Coliforms and E. Coli over the past three years. Based on these observations, it is likely the runoff from the pastures is flowing to CB-103 and then eventually OF-104. Atlas recommends sampling CB-103 and assessing the runoff coming from the pastures during a heavy rain event to determine if OF-104 is impacted by the livestock.
