MS4 General Permit
Town of Canton 2022 Annual Report
 Permit Number GSM 000091
 January 1, 2022 – December 31, 2022
 Primary MS4 Contact: Robert J. Martin, Director of Public Works
 860-693-7863, rmartin@townofcantonct.org

This report documents Canton’s efforts to comply with the conditions of the MS4 General Permit to the maximum extent practicable (MEP) from January 1, 2022 to December 31, 2022.

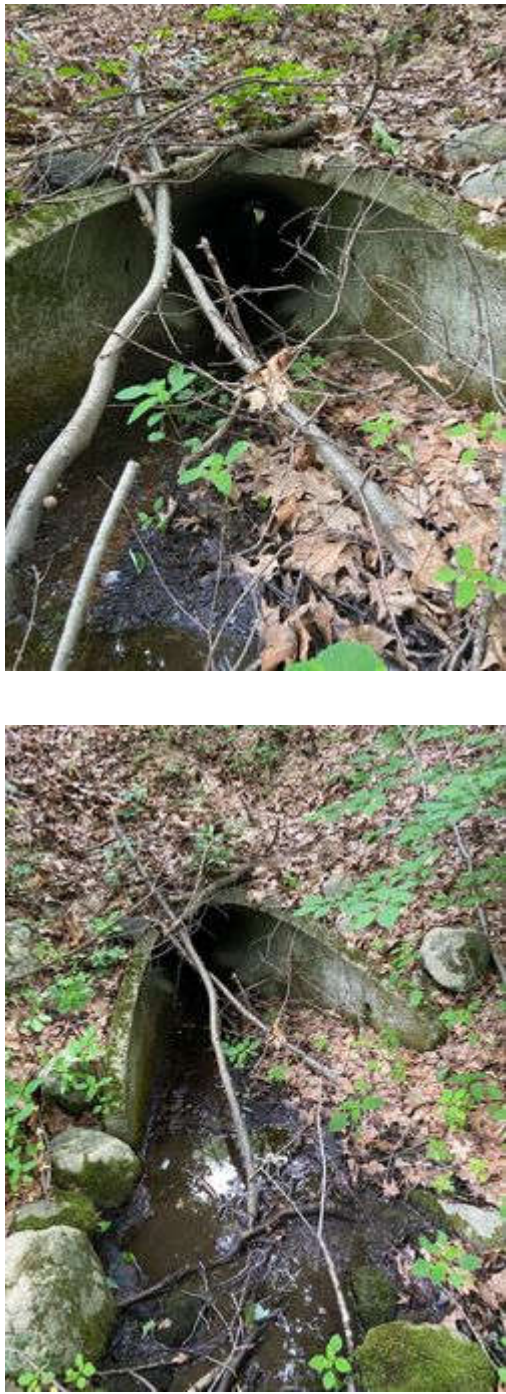
Outfall ID	
OF-198

198	Hop Brook	This outfall was found within 500 ft. of a residential septic failure, and as such, is considered to contribute SVF #12.
199	Hop Brook	This outfall was found within 500 ft. of a residential septic failure, and as such, is considered to contribute SVF #12.
200	Hop Brook	This outfall was found within 500 ft. of a residential septic failure, and as such, is considered to contribute SVF #12.
201	Hop Brook	This outfall was found within 500 ft. of a residential septic failure, and as such, is considered to contribute SVF #12.
203	Hop Brook	This outfall was found within 500 ft. of a residential septic failure, and as such, is considered to contribute SVF #12.
204	Hop Brook	This outfall was found within 500 ft. of a residential septic failure, and as such, is considered to contribute SVF #12.
205	Cherry Brook	This outfall was found within 500 ft. of a residential septic failure, and as such, is considered to contribute SVF #12.
