2021 MS4 ANNUAL REPORT

Town of Canton, Connecticut

MS4 General Permit
Town of Canton 2021 Annual Report
 Permit Number GSM 000091
 January 1, 2021 – December 31, 2021
 Primary MS4 Contact: Robert J. Martin, Director of Public Works
 860-693-7863, rmartin@townofcantonct.org

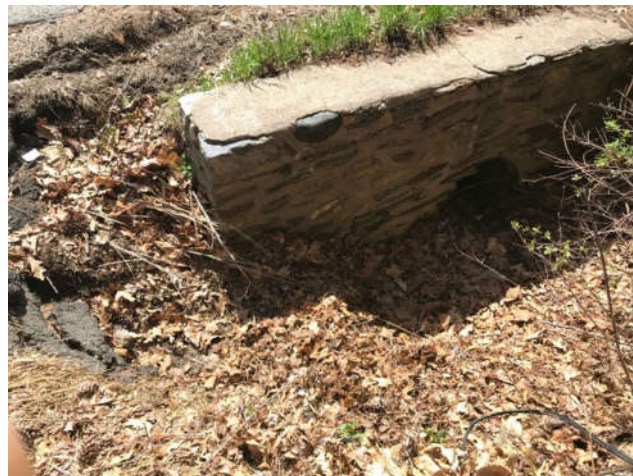
Outfall:

Material	Concrete
Subtype	Other
Diameter	18"
Condition	Good
Erosion Control	Fair

This outfall takes runoff directly from road, discharges next to OF 40.

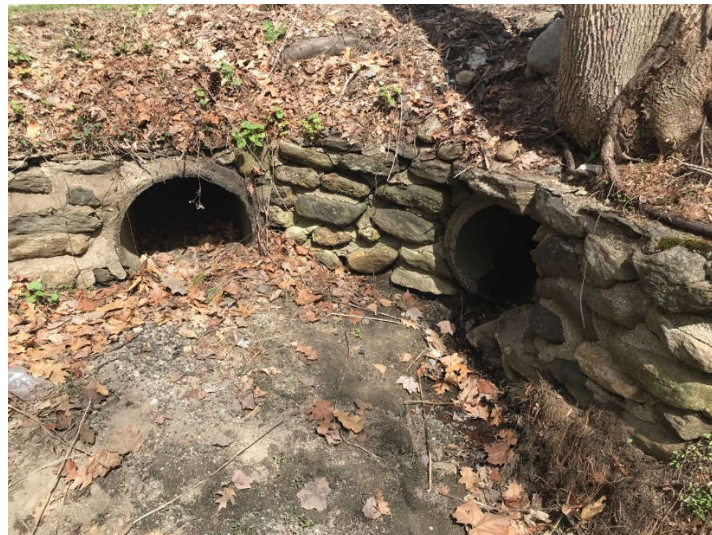
Outfall:

Material	Concrete
Subtype	Other
Diameter	18"
Condition	Good
Erosion Control	Good

Next to OF 39.

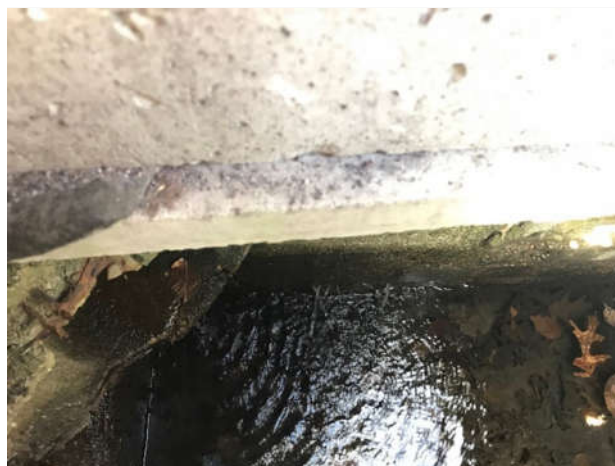
Outfall:

Material	Concrete
Subtype	Endwall
Diameter	
Condition	Poor
Erosion Control	Excellent

Endwall is deteriorated enough where suspected groundwater is entering catch basin.

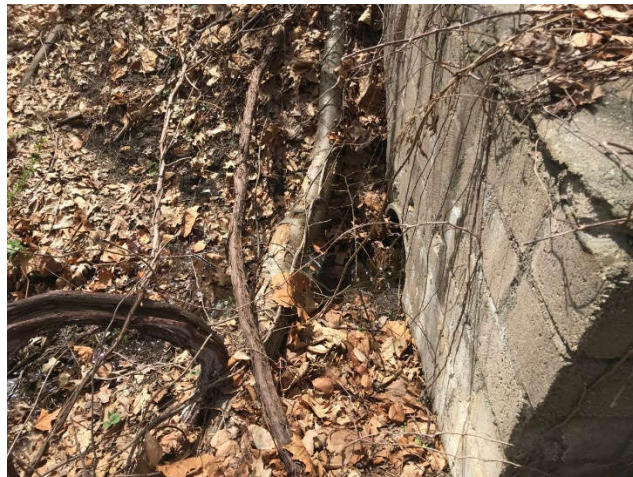
Outfall:

Material	Concrete
Subtype	Endwall
Diameter	12"
Condition	Good
Erosion Control	Good

Part of OF pipe silted in.

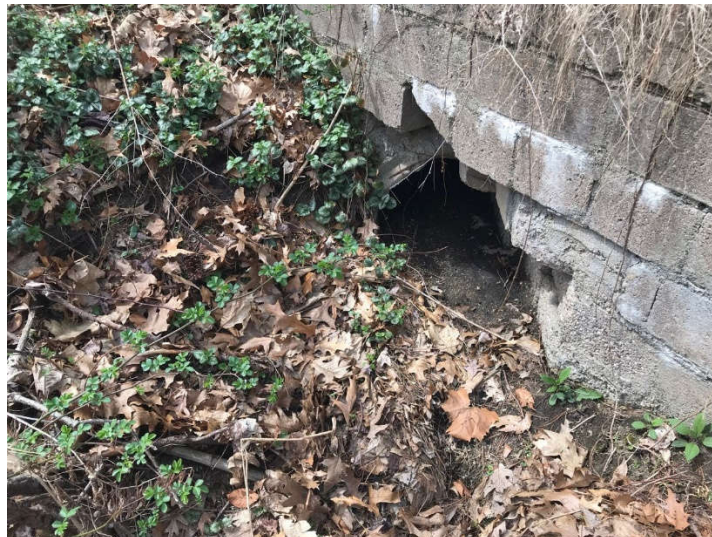
Outfall:

Material	Concrete
Subtype	Endwall
Diameter	24"
Condition	Fair
Erosion Control	Fair

Endwall and part of outfall is slightly broken. Part of outfall is silted in.

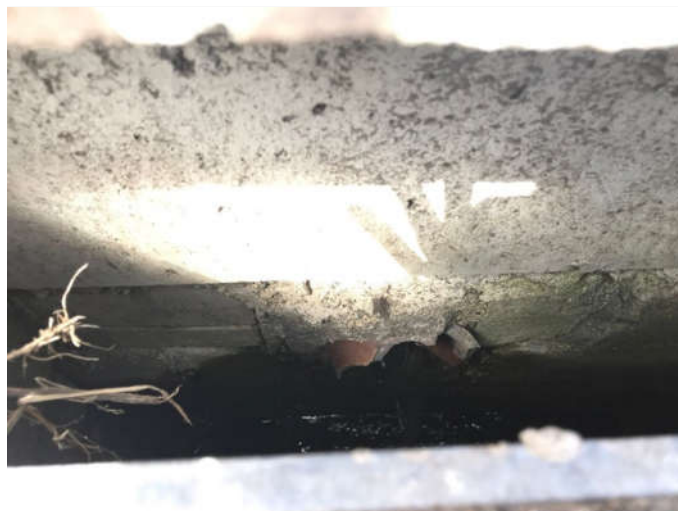
Outfall:

Material	Concrete
Subtype	Other
Diameter	6"
Condition	Fair
Erosion Control	Excellent

This is possibly from a residence. ATC has no indication of where this pipe comes from.

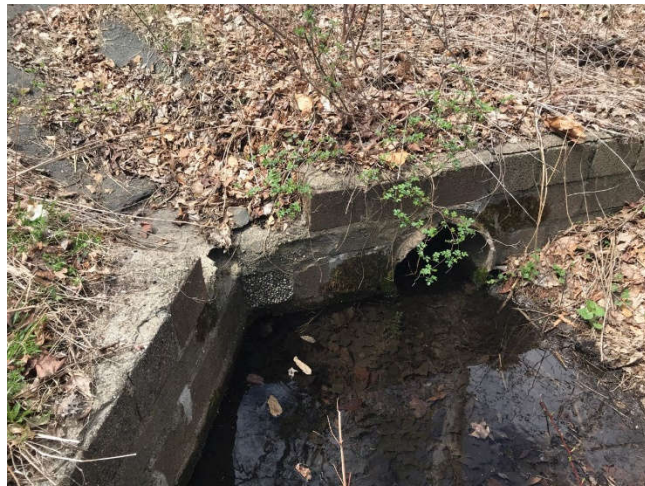
Outfall:

Material	Concrete
Subtype	Endwall
Diameter	18"
Condition	Good
Erosion Control	Good

OF discharge area filled with leaf litter.

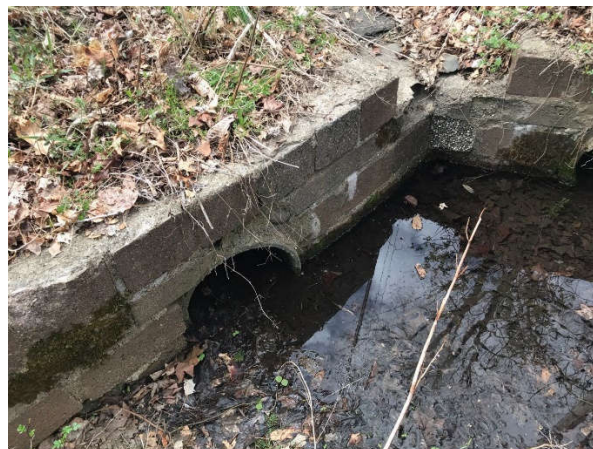
Outfall:

Material	Concrete
Subtype	Endwall
Diameter	18"
Condition	Good
Erosion Control	Fair

Next to OF 108. Discharge area filled with leaf litter. Some silt and sediment in pipe.

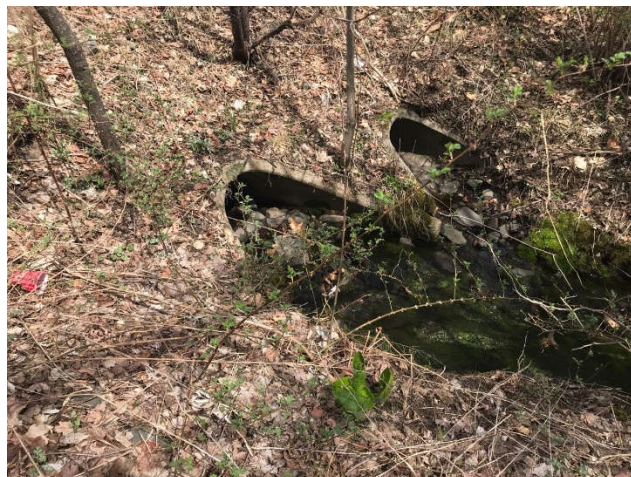
Outfall:

Material	Concrete
Subtype	Flared End
Diameter	18"
Condition	Good
Erosion Control	Good

OF Is directly next to outfall 106. This outfall is discharging, connected to school zone. High algae at discharge location.

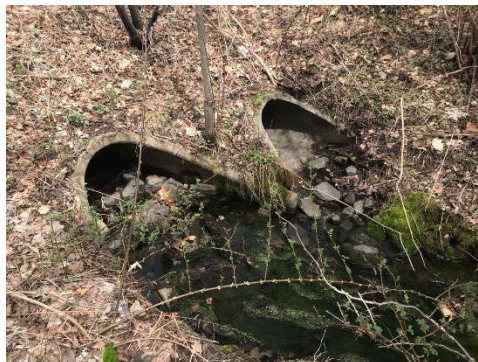
Outfall:

Material	Concrete
Subtype	Flared End
Diameter	12"
Condition	Good
Erosion Control	Good

Directly next to OF 106. No discharge, in good condition.

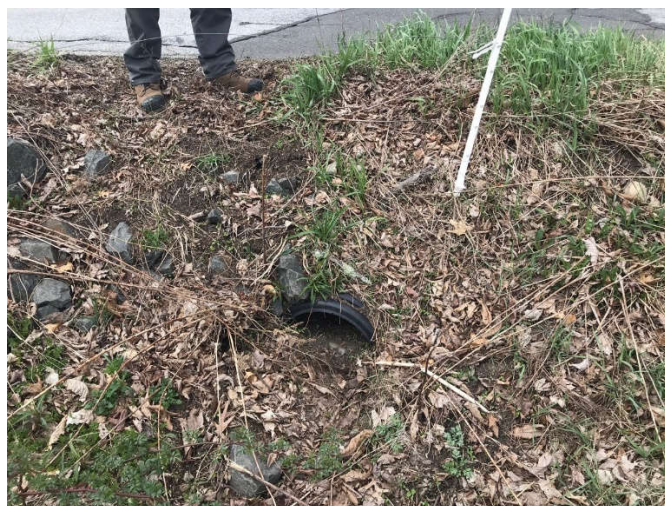
Outfall:

Material	Plastic
Subtype	Other
Diameter	12"
Condition	Fair
Erosion Control	Fair

OF is mostly silted in. Discharges to farm/wetland area. Receives discharge from Connecting OF/culvert 103, which comes from a ditch.

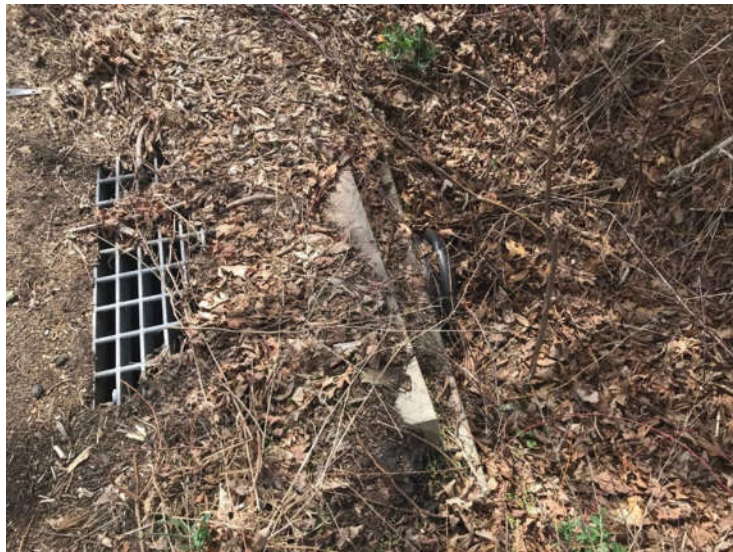
Outfall:

Material	Plastic
Subtype	Other
Diameter	12"
Condition	Poor
Erosion Control	Fair

Cb to small ditch on side of road, leads to OF 104.

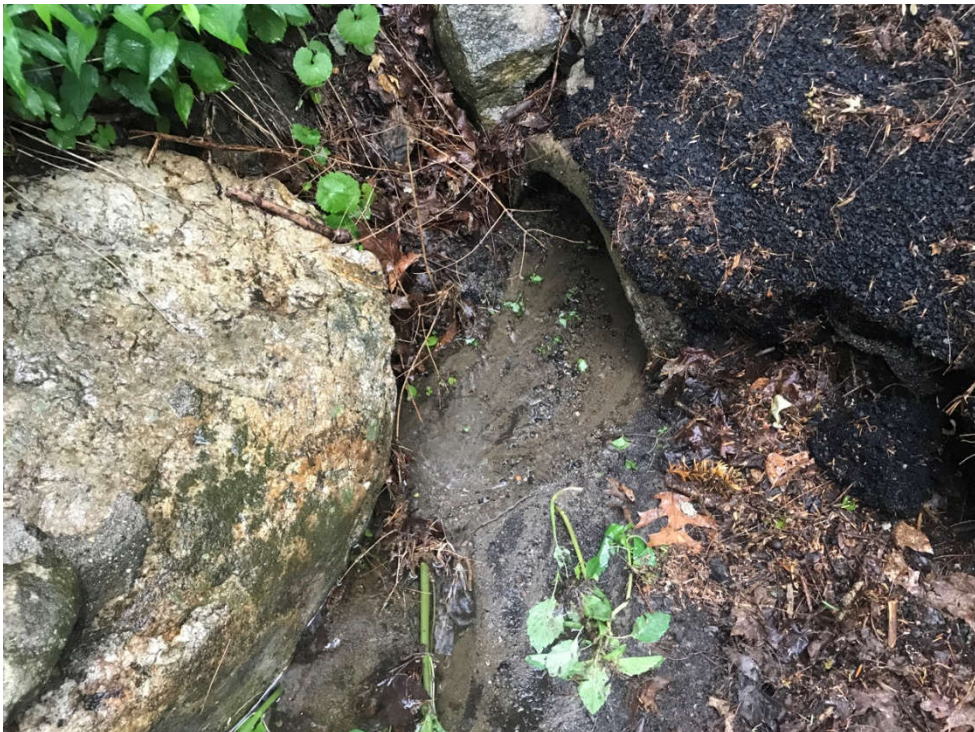
Outfall ID
OF-206

Outfall ID	Inspection Date	Condition	Discharge Description	Discharge Visual	General Parameters							Bacterial	
					Temperature (°C)	pH (SU)	Dissolved Oxygen (mg/L)	SPC (uS/cm)	ORP (mV)	Turbidity (NTU)	Odor	Escherichia Coli MPN/100mL	Total Coliforms
OF-206	9/1/21	Good	OF not discharging, sample taken from road runoff. Dark yellow with some floating particulates.

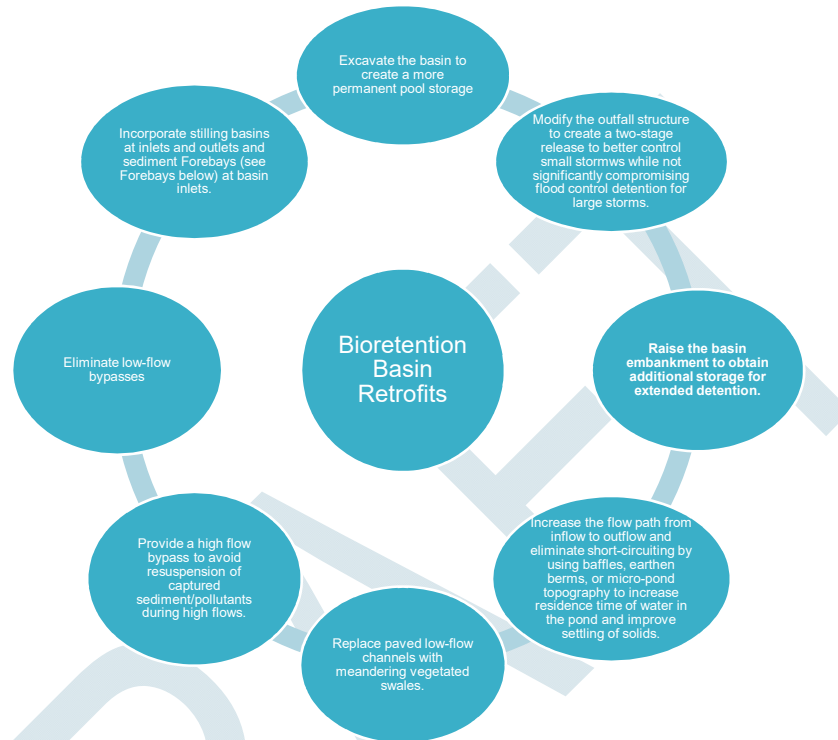
Graphic 2: Bioretention Basin Retrofit Projects for Improved Water Quality Mitigation

Graphic 2 summarizes modifications to existing Bioretention basins for improved water quality mitigation. **If the following modifications are made to a basin that is directly connected to the MS4 System, then it can be considered a Retrofit Project.**

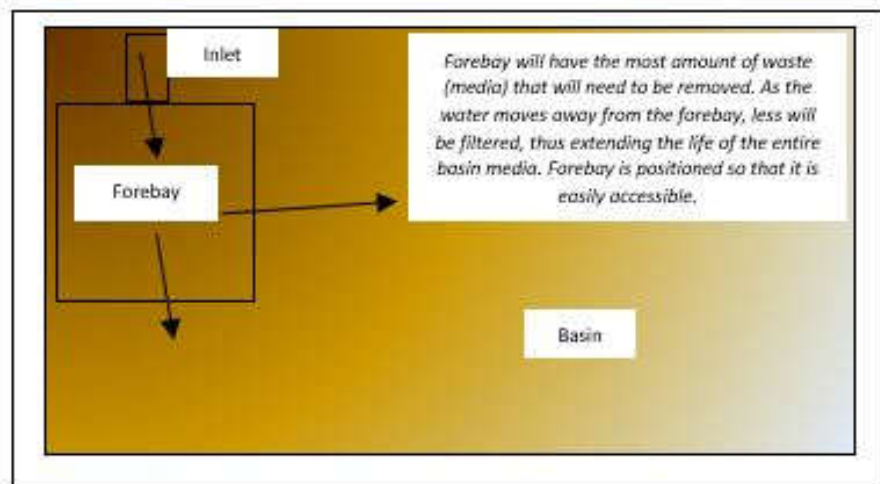
Graphic 6: Forebays

Disadvantages of a forebay include the removal of only coarse sediment fractions; therefore, soluble pollutants will remain and potentially discharge to the entirety of the basin. There is also no recharge to groundwater in a forebay, as well as no control of the volume of runoff. *Frequent maintenance is essential* (MADEP, N.D.).

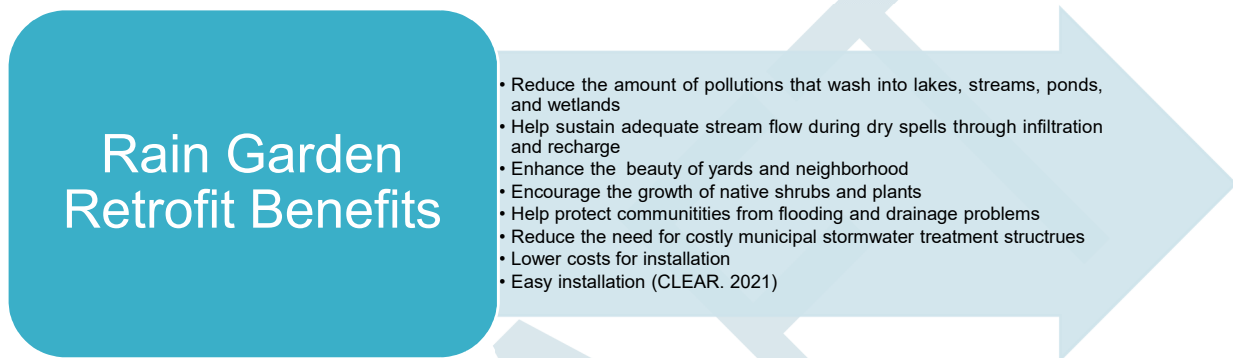
Graphic 8: Rain Garden Retrofit Benefits

Rain gardens are a relatively easy and aesthetic Retrofit Project option for small communities or homes. According to NEMO, a rain garden is “a depression (about 6 inches deep), that collects stormwater runoff from a roof, driveway, or yard, and allows it to infiltrate into the ground” (CLEAR, 2021.). Typically, a residential rain garden is 50 to 100 square feet, and includes a variety of native shrubs and plants. *A rain garden should never be installed in a low area or an area that is wet; it is not a water garden or wetland.*
