# ANNUAL REPORT

TOWN OF CANTON  
JANUARY – DECEMBER 2023

# 2023 MS4 ANNUAL REPORT

MS4 General Permit  
Town of Canton 2023 Annual Report  
Permit Number GSM 000091  
January 1, 2023 – December 31, 2023  
Primary MS4 Contact: Robert J. Martin, Director of Public Works  
860-693-7863, [rmartin@townofcantonct.org](mailto:rmartin@townofcantonct.org)

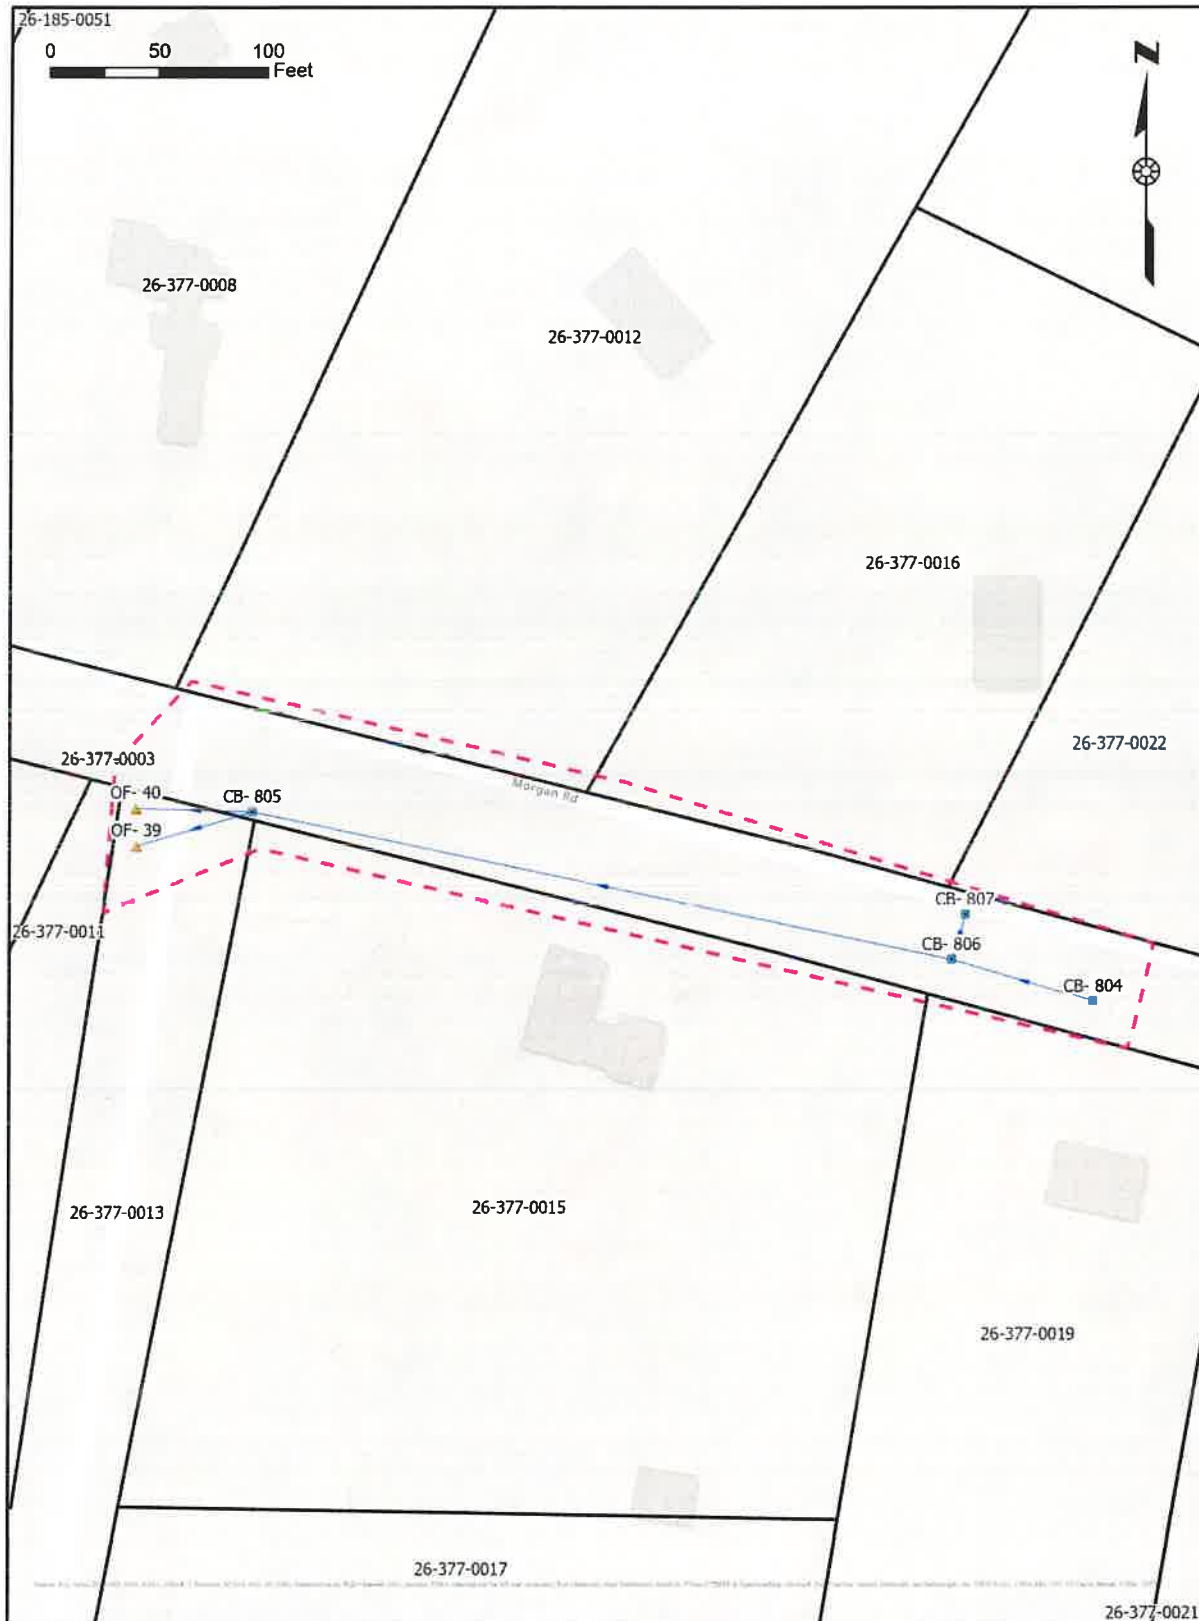
2023 Annual Report  
OF-39/40 Catchment  
Investigation

**Rationale:** Atlas staff noted there were additional pipes discharging into CB-804. Samples collected from OF-40 indicated high levels of Total Coliforms and E. Coli over the past three years. Based on these observations, it is possible there is illicit discharges coming from the pipes. These pipes seem to be connected to the residential houses on Camille Lane, potentially from the house at 11 Camille Lane. In addition, septic failure data was obtained. In 2021, a failing septic tank was replaced 0.1 miles from OF-39 and OF-40. In 2023, a sewage overflow occurred 0.2 miles from the outfalls, with the leaching field needing to be replaced afterwards. These and other potentially aging septic systems may be contributing to the elevated bacteria levels in these outfalls.

Atlas recommends sampling all four catch basins and assessing if there is runoff coming from the additional pipes during a heavy rain event to determine if OF-40 is impacted by illicit discharges.

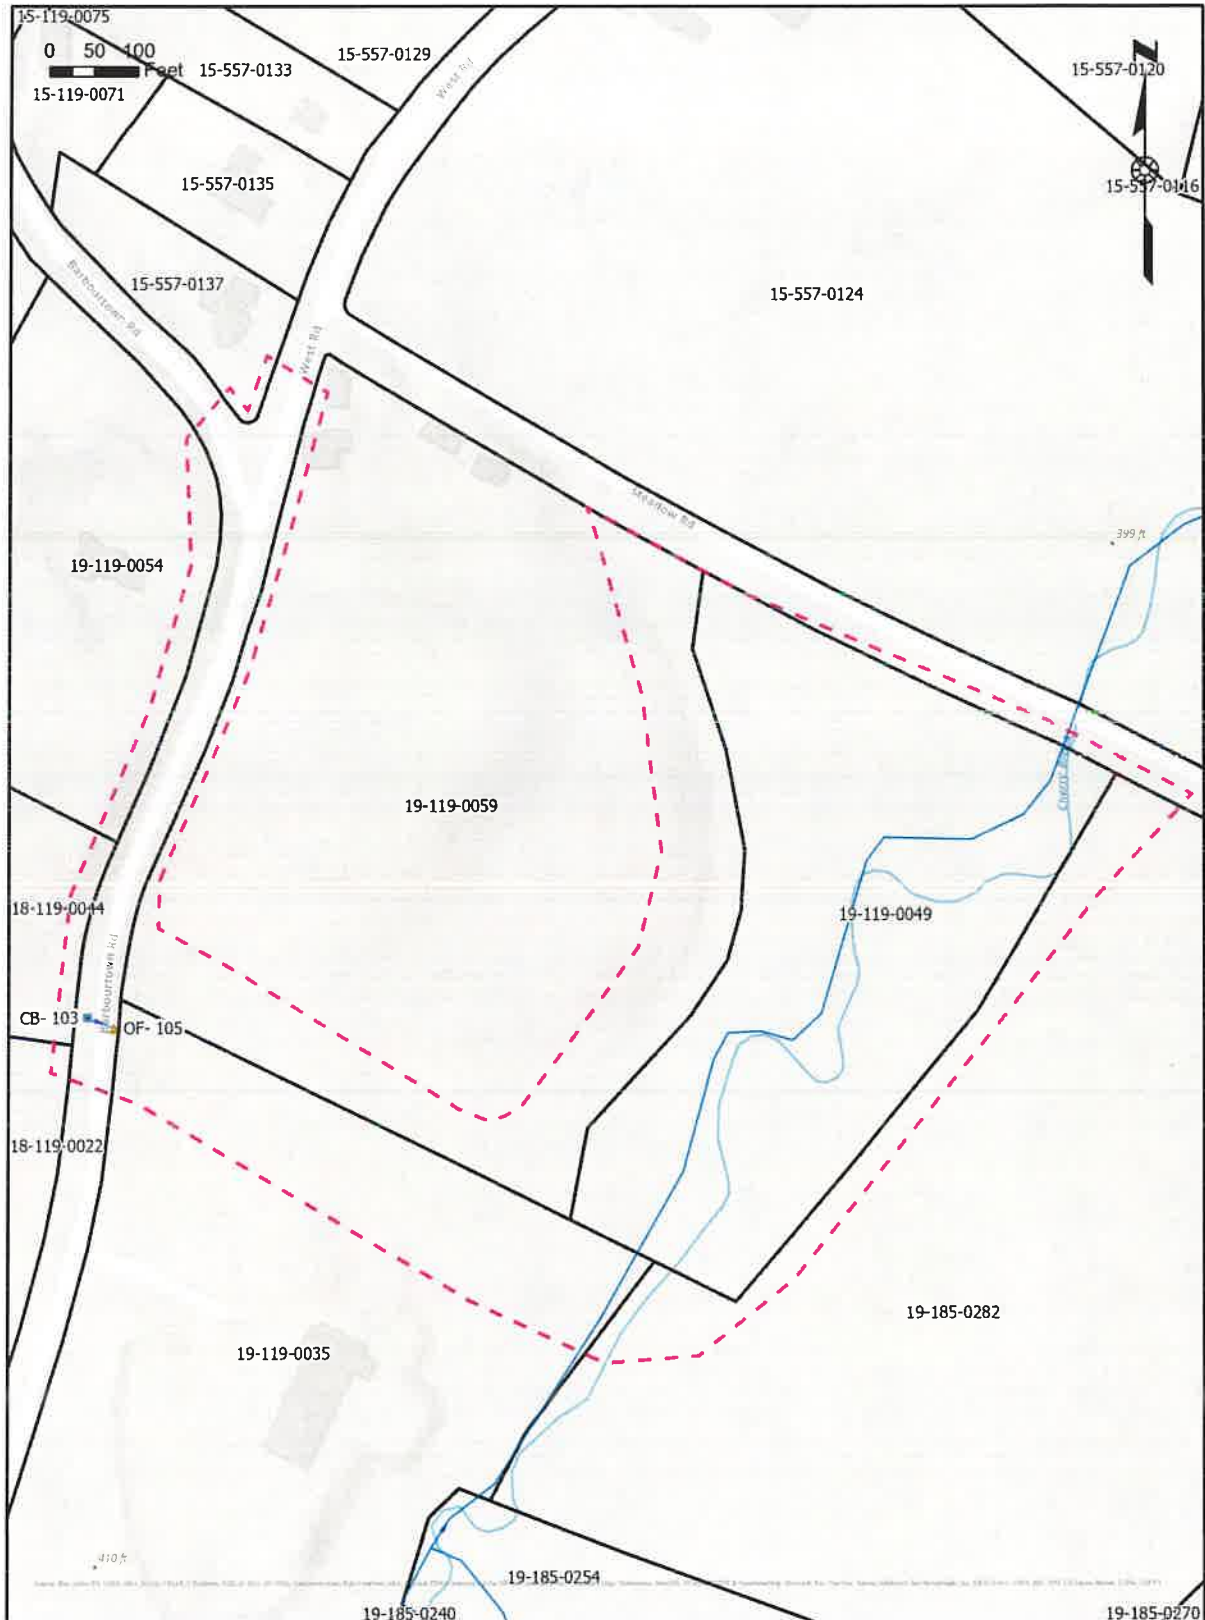
### OF-104 Catchment Investigation

**Rationale:** Atlas staff noted there was a pasture with cattle and horses on land adjacent to the outfall (Parcel No. 19/119/0059). Samples collected from OF-104 indicated high levels of Total Coliforms and E. Coli over the past three years. Based on these observations, it is likely the runoff from the pastures is flowing to CB-103 and then eventually OF-104. Atlas recommends sampling CB-103 and assessing the runoff coming from the pastures during a heavy rain event to determine if OF-104 is impacted by the livestock.

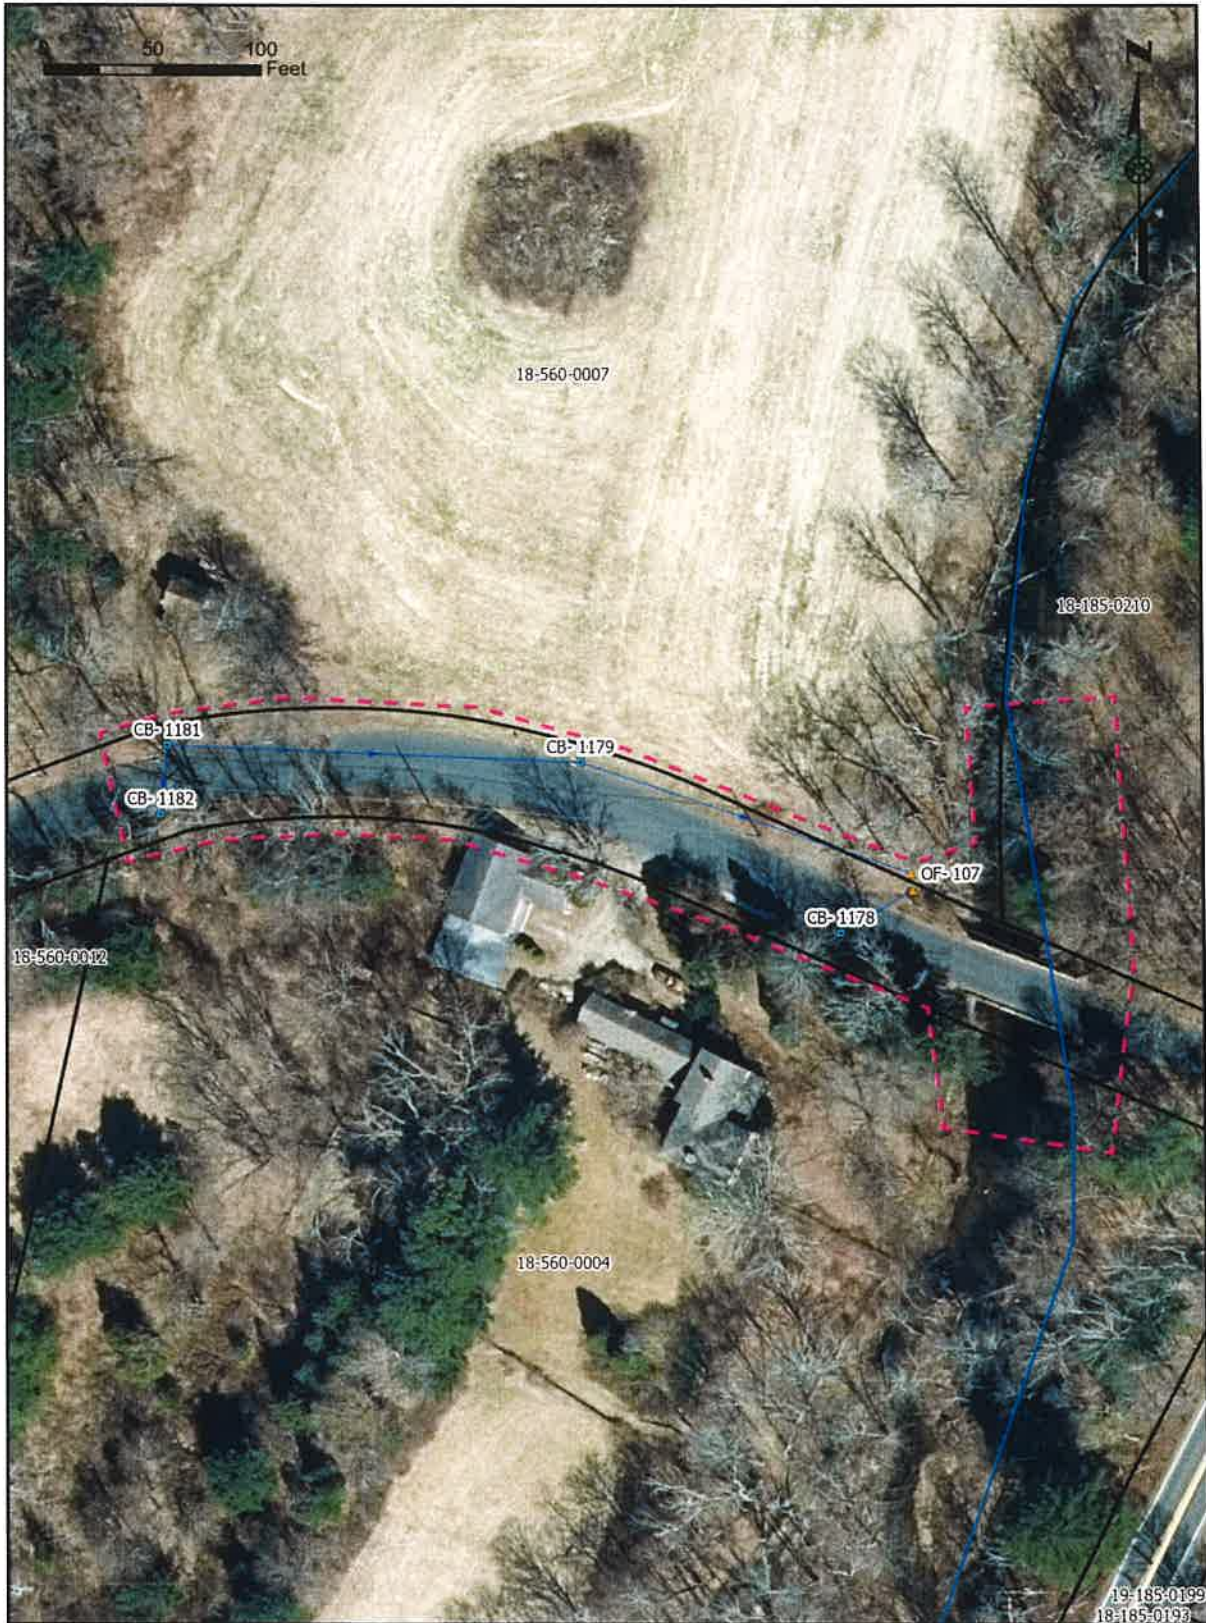
**Rationale:** Atlas staff noted the parcels near the catch basins were mostly wooded. Samples collected from OF-107 and OF-108 indicated high levels of Total Coliforms and E. Coli over the past three years. Based on these observations, it is possible that runoff from West Mountain Road is contaminated. Atlas recommends sampling all four catch basins and assessing where the bacteria could be originating from during a heavy rain event. In addition to this an investigation, septic failure data was obtained. An aging septic tank was replaced on West Mountain Road, approximately 0.7 miles from OF-107 and OF-108. It is possible that this and other aging septic systems that have not yet been replaced in the area are contributing to the elevated bacterial levels from the outfalls.
